**From:** Ken Nielson  
**To:** fpalacios@bbpwr.com  
**CC:** Bill Morgan; James Nelson; Jerry Finlinson  
**Date:** 12/30/2002 9:27 AM  
**Subject:** Intermountain Power. Contract 100210 - Overfire air system controls

Summary of the U1 OFA work completed by IPSC Maintenance and Rocky Mountain personnel under the direction of Phil Hailes and Ken Nielson during the 11/26/03 mini-outage. Photos showing the problems listed below are found in the following directory - **N:\Current\Projects\IGS02\IGS02-14 Boiler Modifications - JHN\6.Documentation\U1 Mini-outage Photos-Control Linkage & bearings.**

# Engineering Services Inspection Report

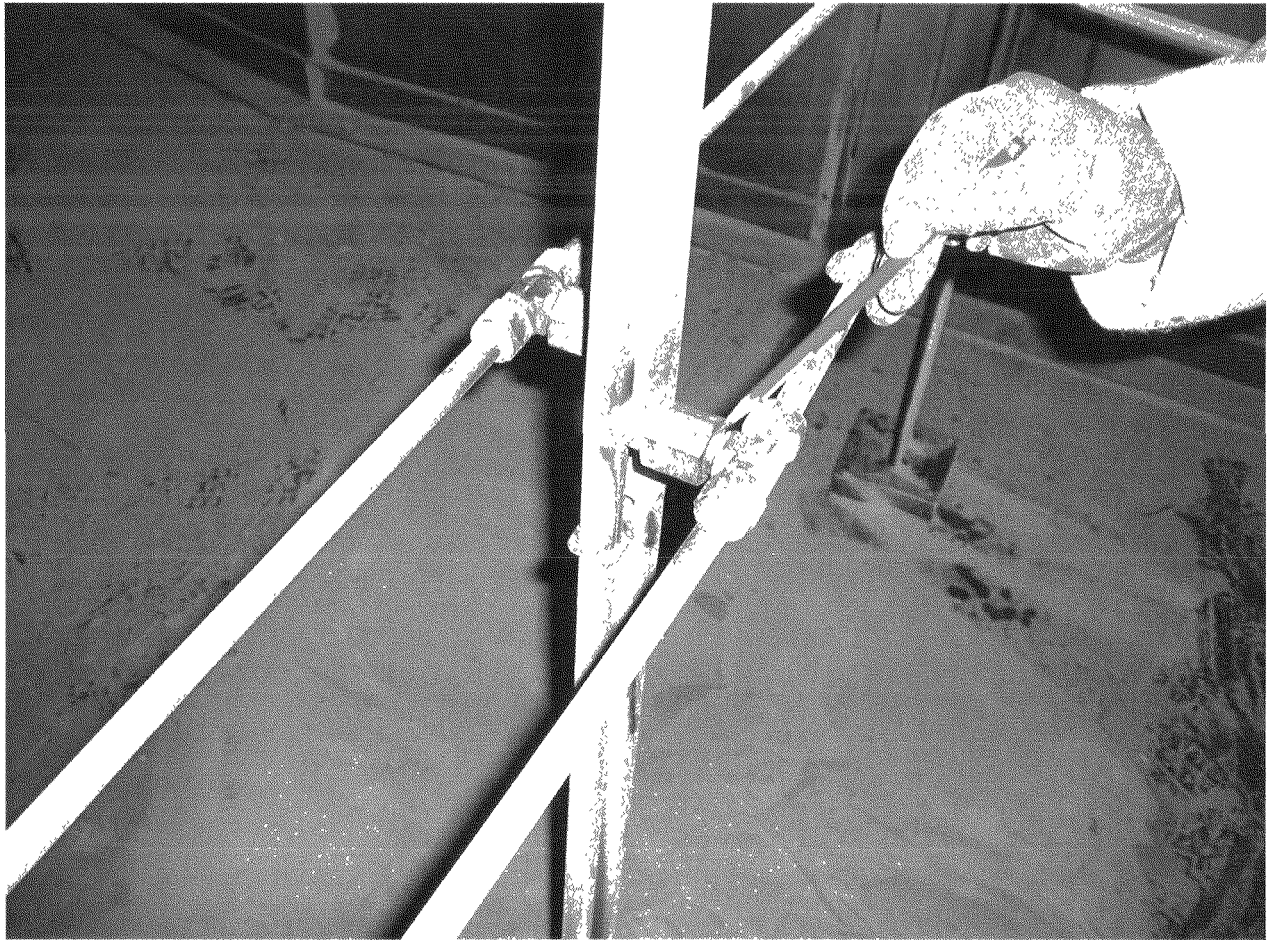
Inside the windbox every fitting where the T is connected to the pitot has a major air leak that needs welding repair. Weld 6 fittings on the pitots in each corner of the overfired air windbox, SE, SW, NE, NW.

Obviously you should be recommending that the overfired air fittings we welded in place. When we opened it up for inspection, every one of those fittings on the pitot tubes was leaking major gushers. The smaller fittings were galled on, so we couldn't take the fittings off to tighten. We simply welded the fittings in place. You should recommend they be installed with welding, because the tubing fittings cannot withstand the service temperatures.
